Navajo Abandoned Uranium Mine

Site Screen Report

Cove Mesa Mines (AEC Plot 7) AUM Site

Weston Solutions, Inc.

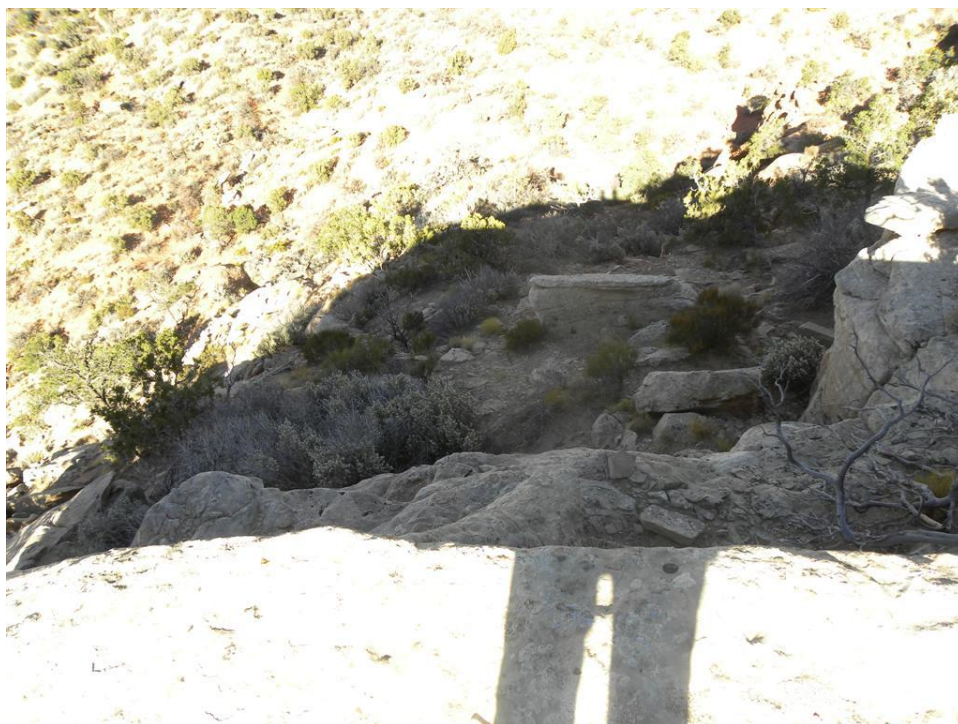
Photo 2. Site #37 – Cliff area with waste rock

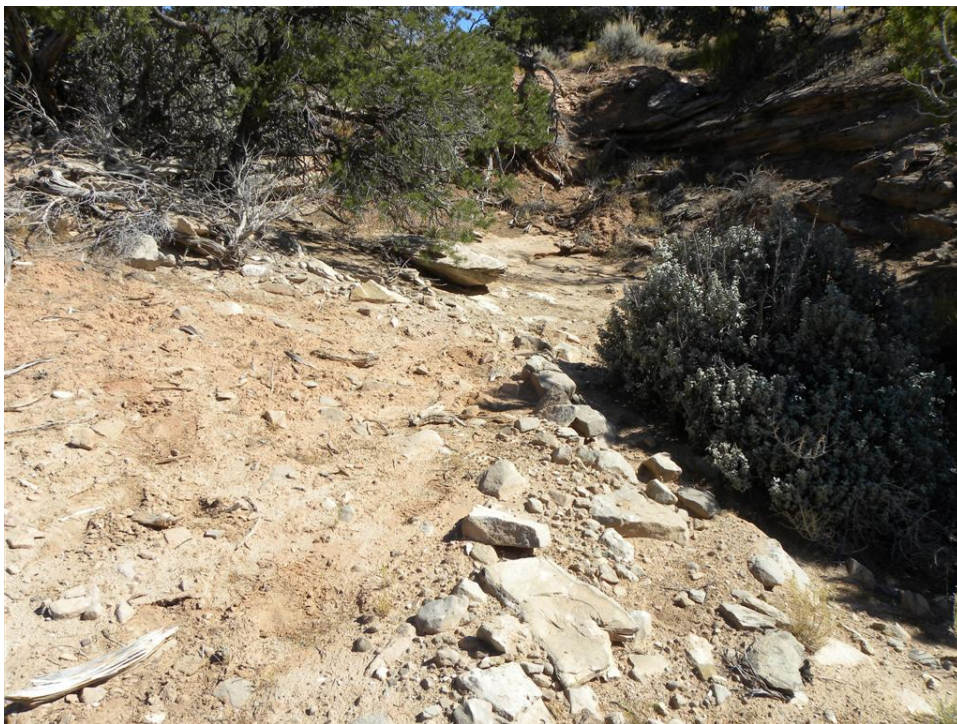
Waste pile found along edge at south of site, 10' x 15' x 10'; another down slope 500' x 125' area; with a total estimated volume of 11,629 yd³

Photo 8. Site #39 – Down slope area and waste rock

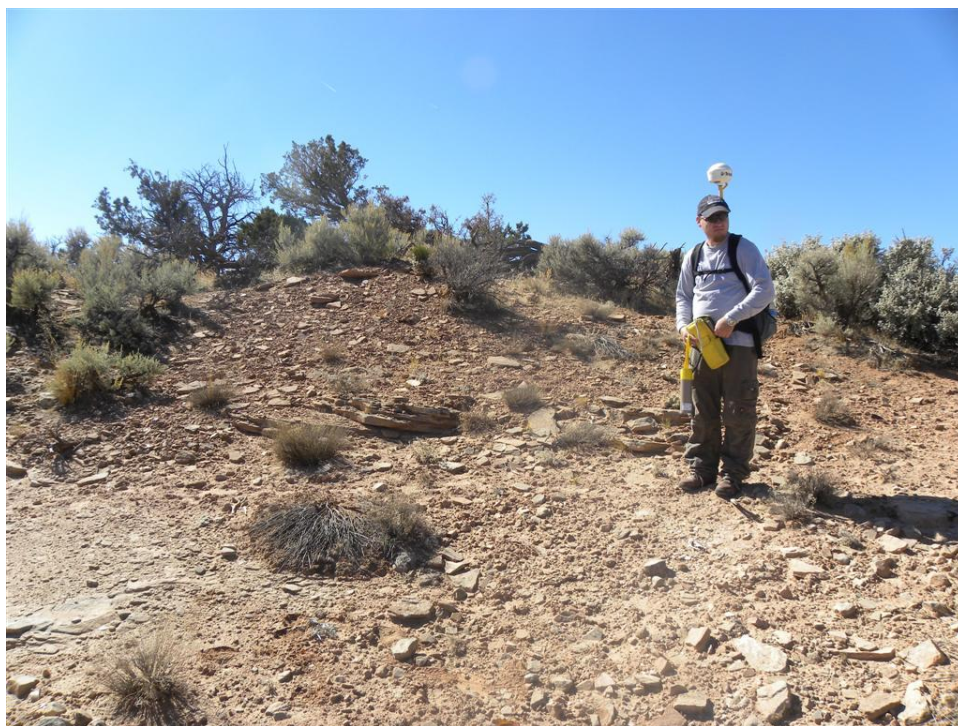
Photo 9. Site #430– Waste pile

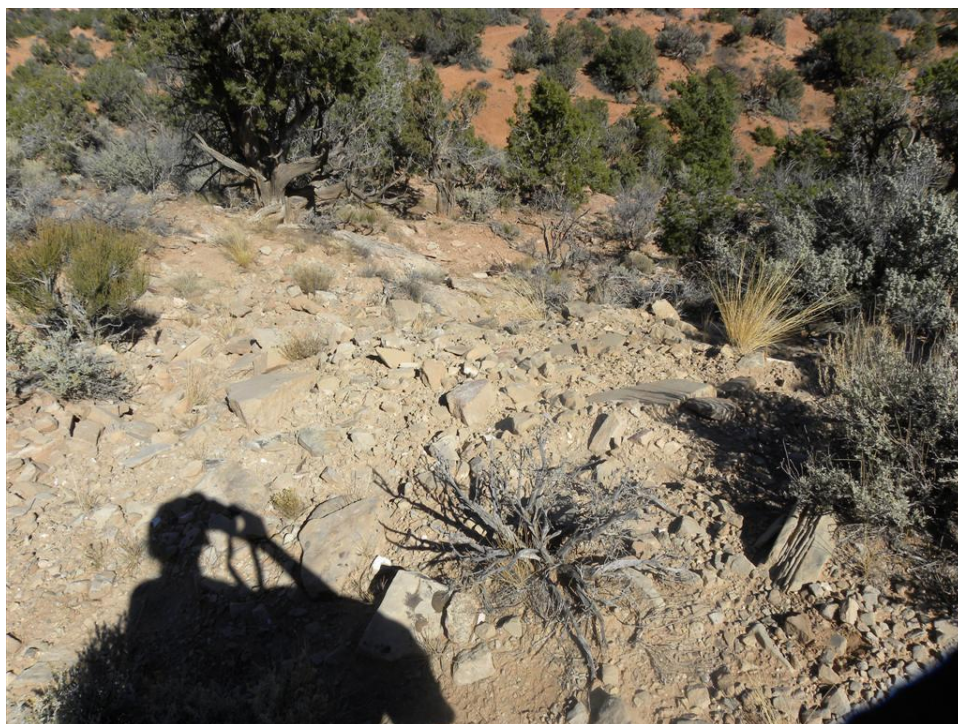
Photo 11. Site #430– Waste pile

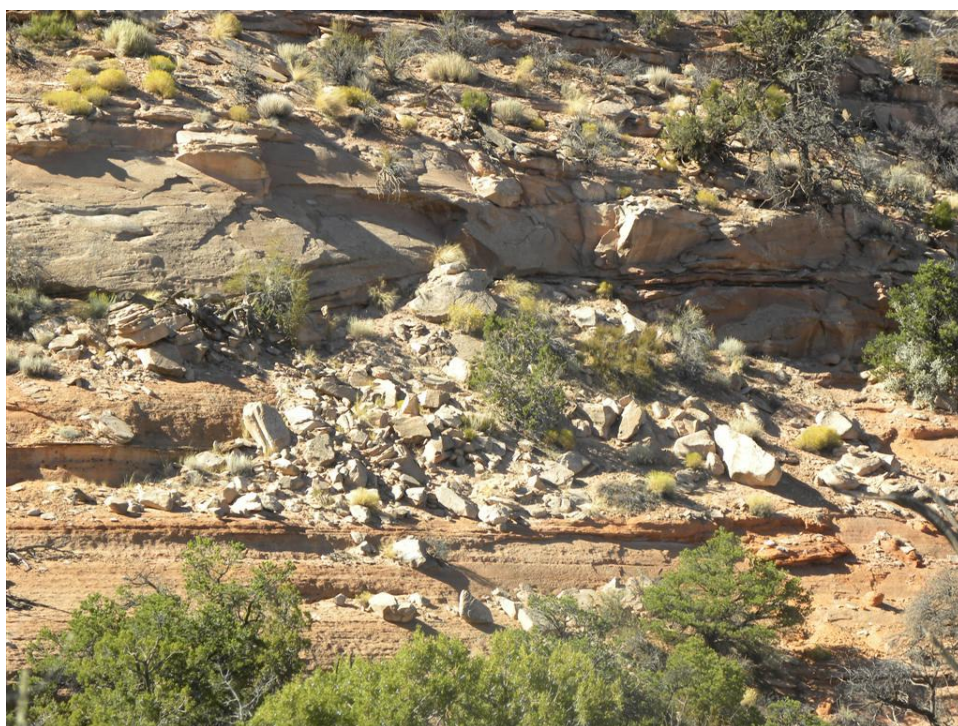
Photo 16. Site #434– Waste pile

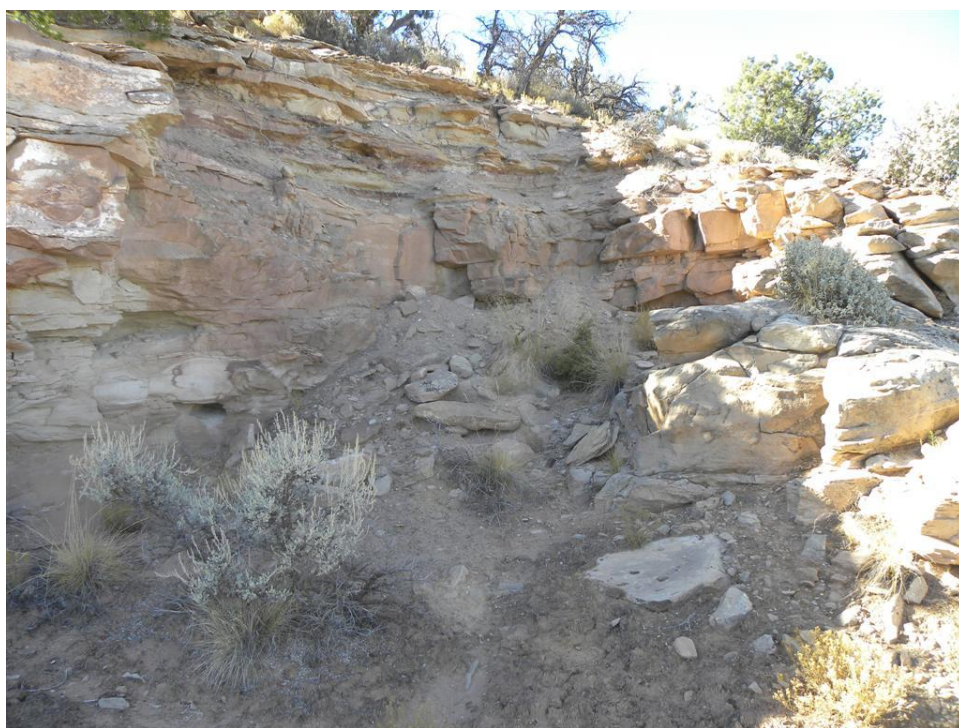
Waste piles noted on the NE and NW corners, the SE area, and large debris 10' x 150' washed down cliffs about 250', with a total estimated volume of 278 yd³

Photo 18. Site #497– Waste Rock

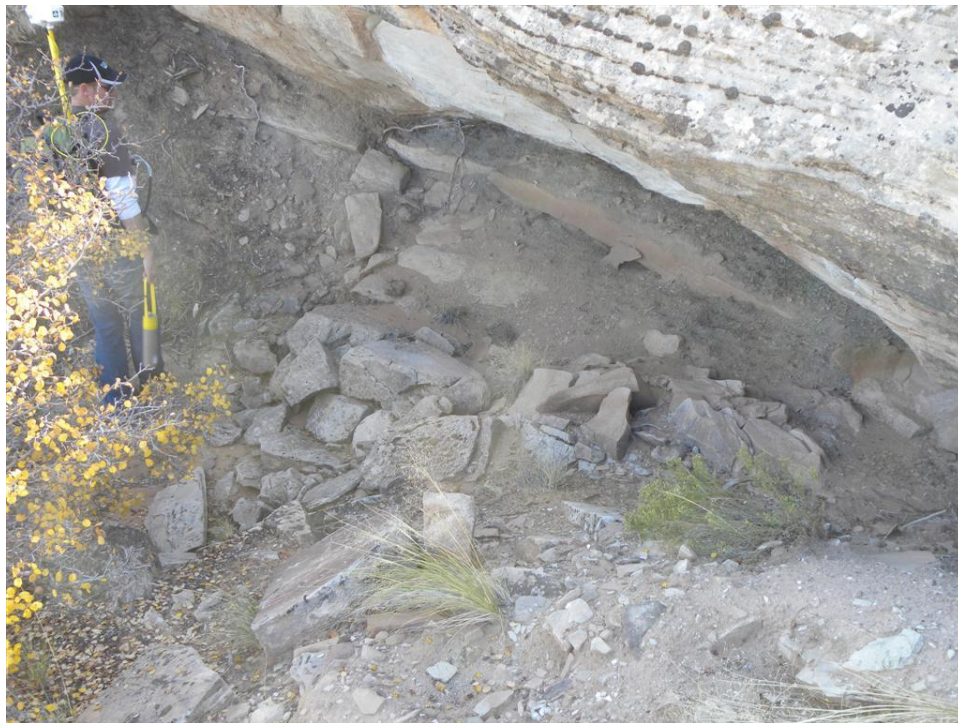
Possible adit caved in due to erosion; another possible adit found closed off due to erosive landslide

Photo 19. Site #497– Possible adit

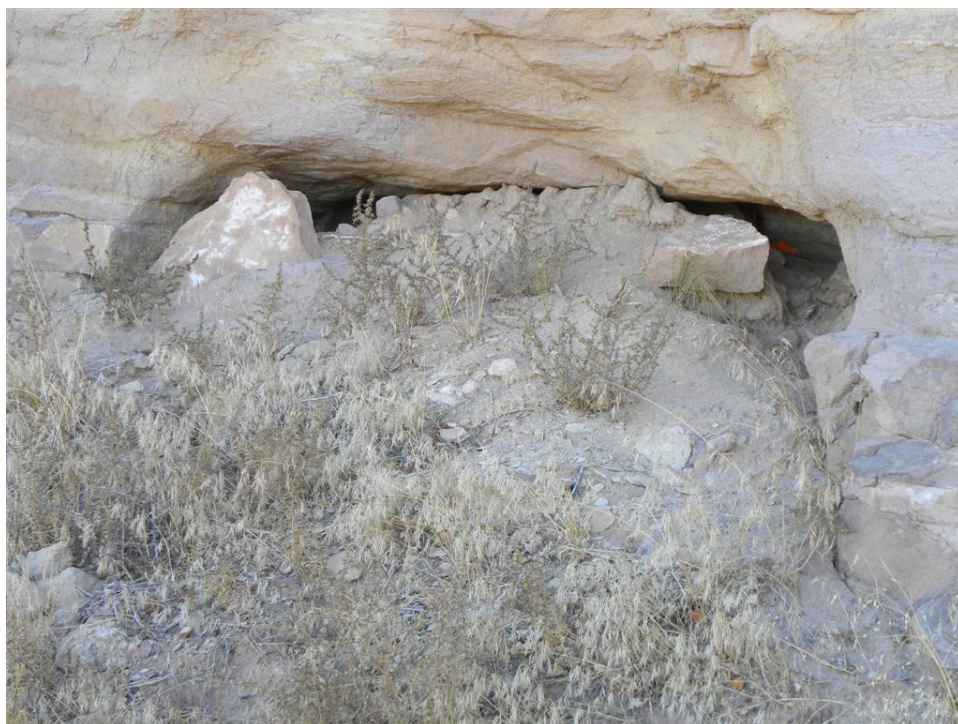
Photo 20. Site #497– Additional possible adit

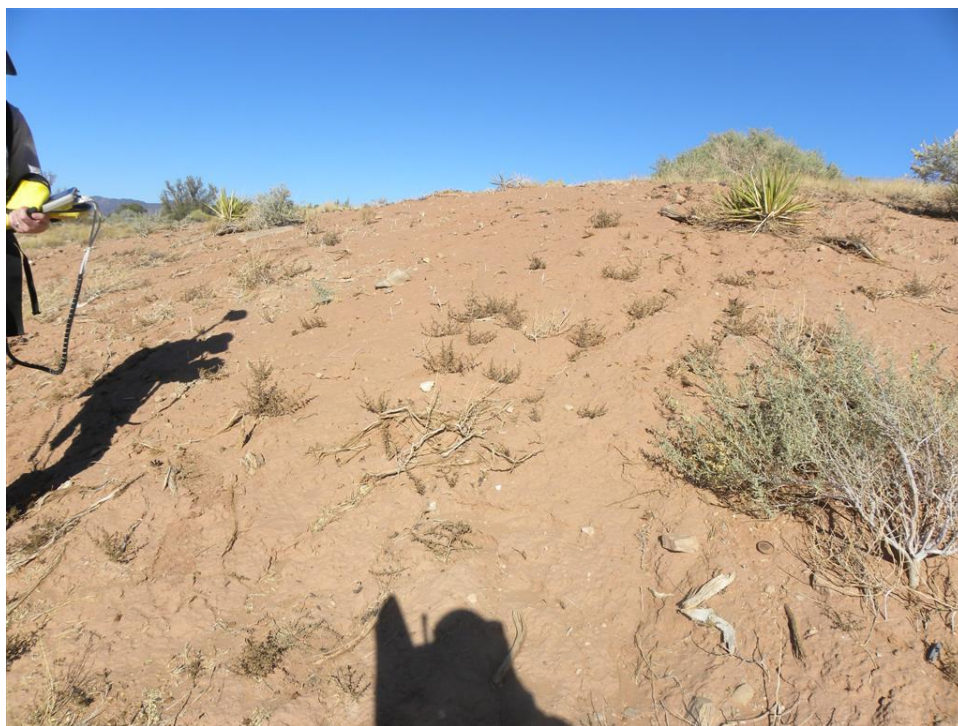
Photo 29. Site #498– Possible reclamation cap

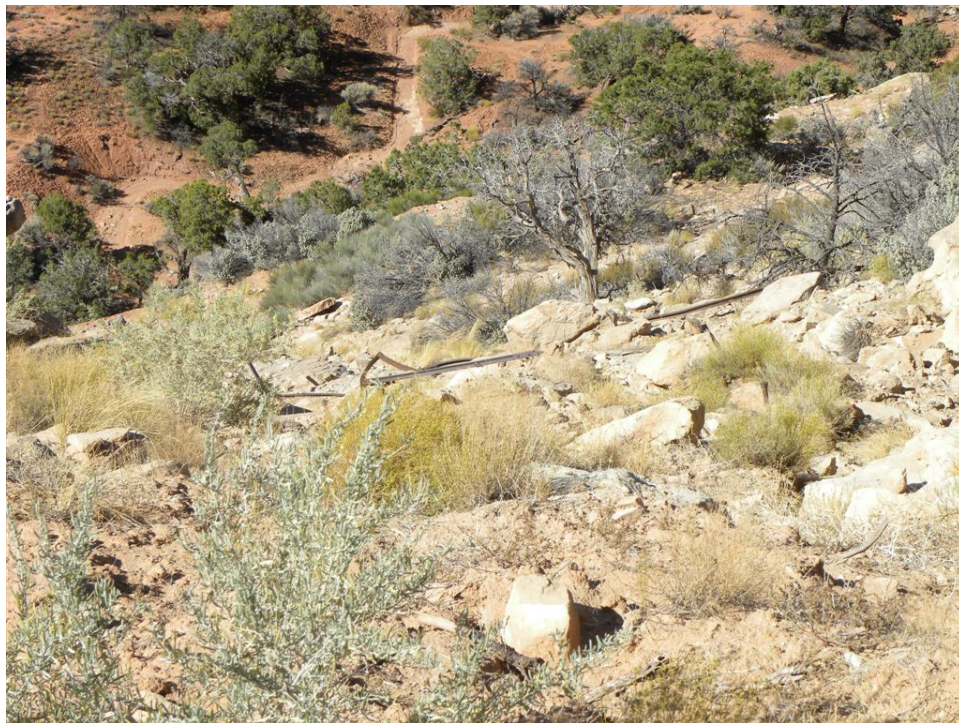
Photo 33. Site #501– Waste debris

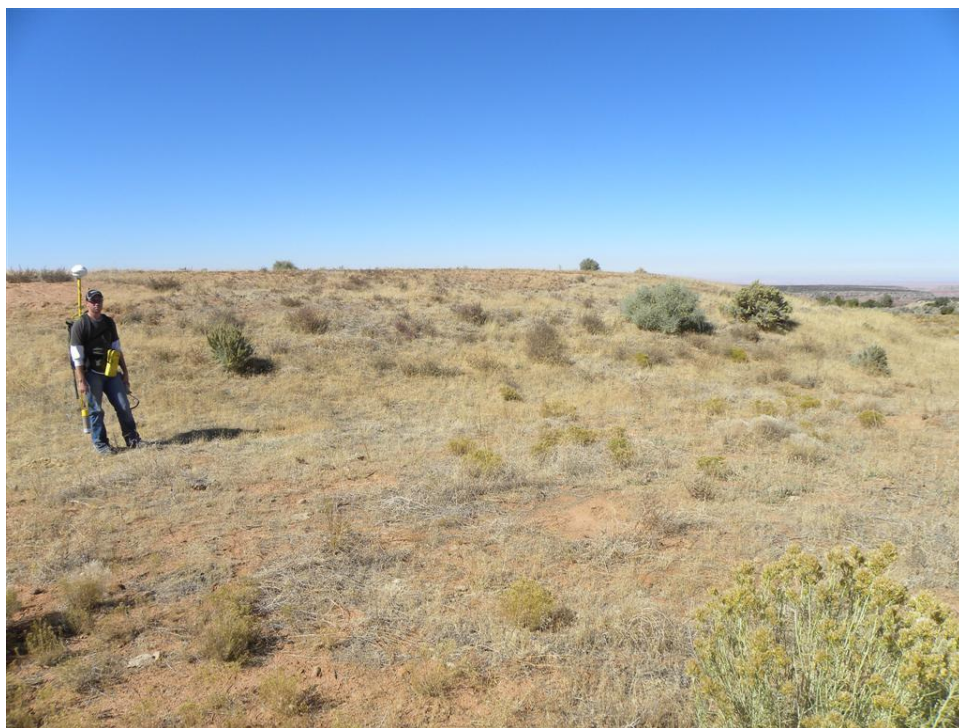
Photo 34. Site #501– Reclamation cap

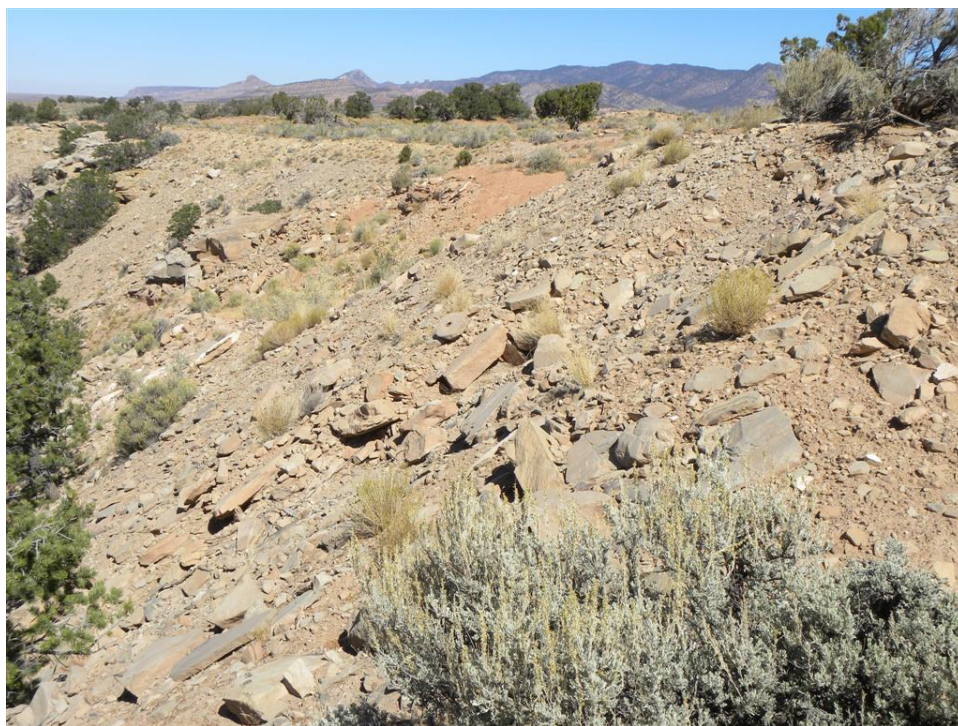
Photo 37. Site #501– Waste pile

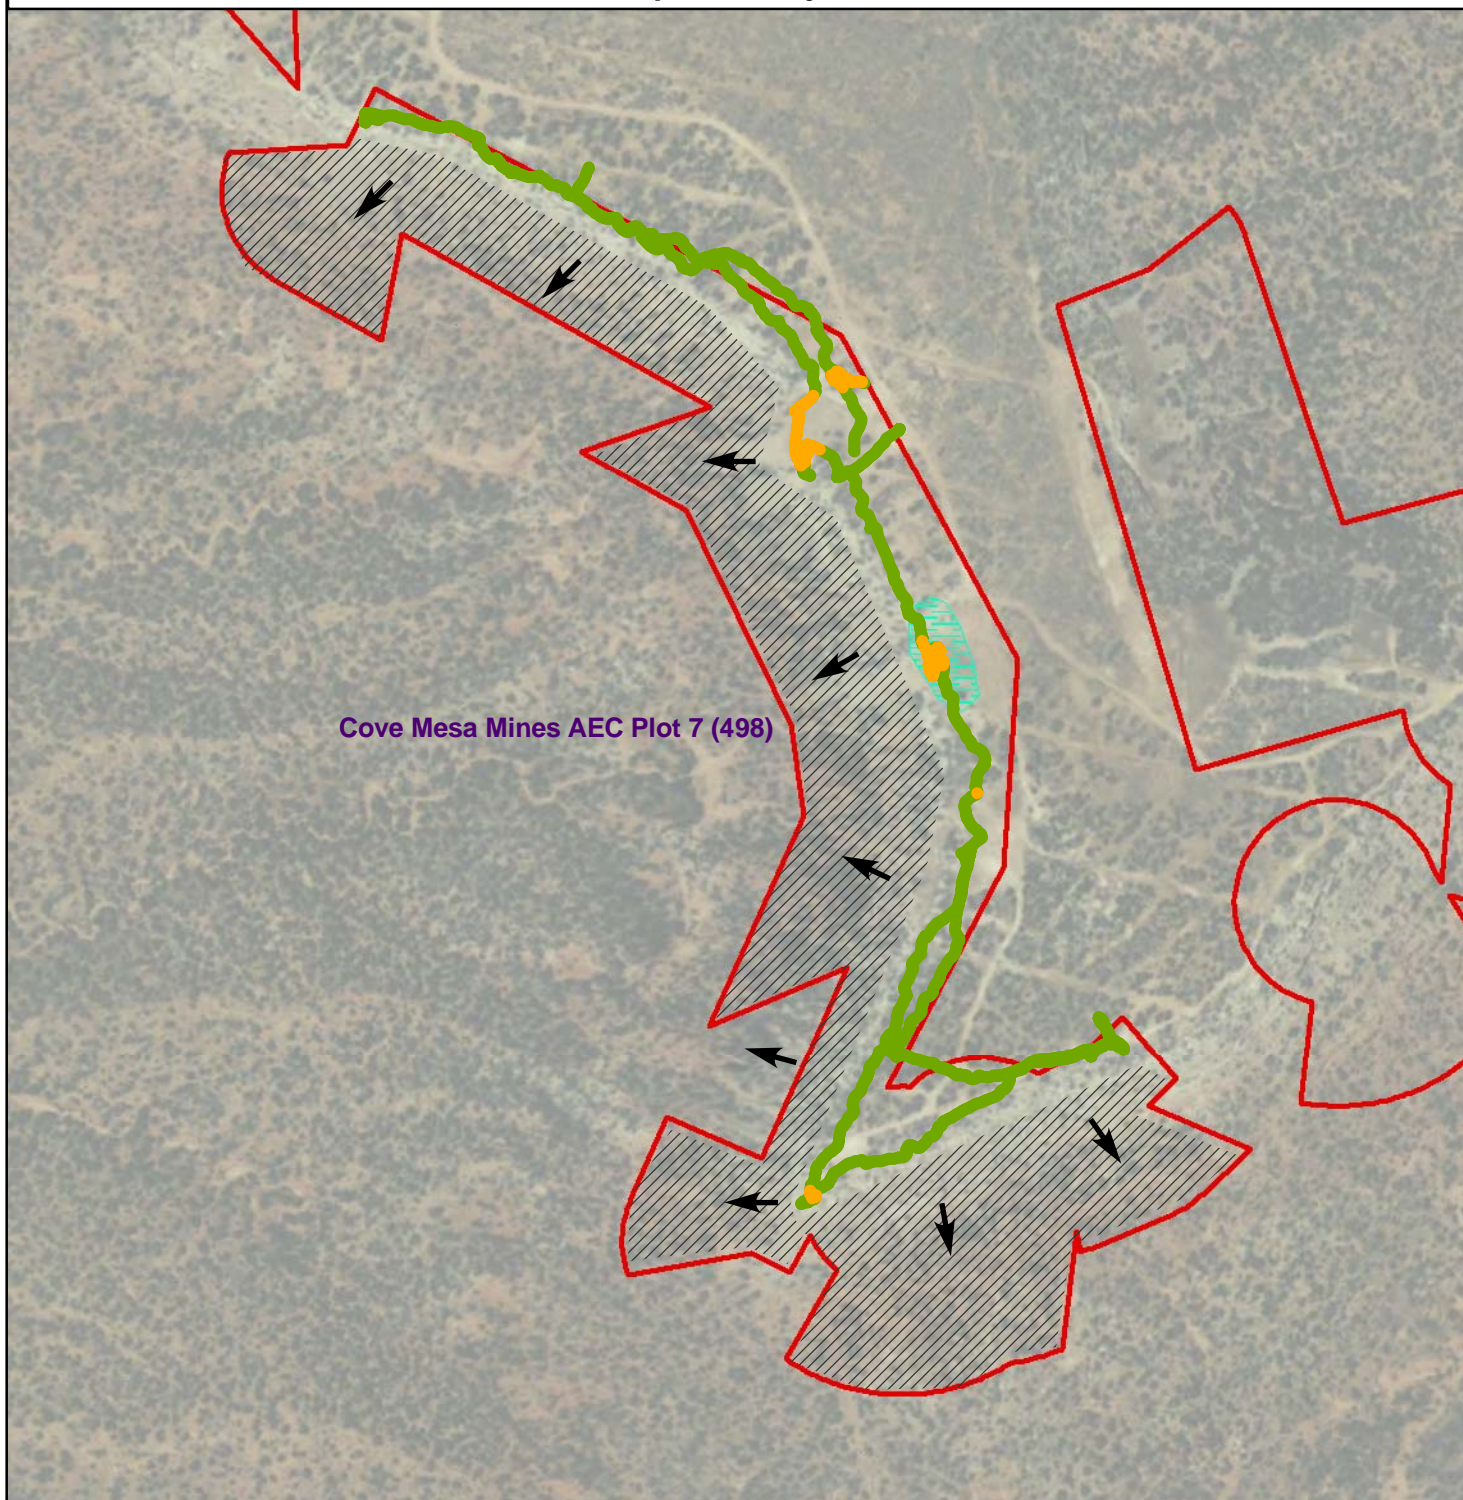
**Figure 16 - Gamma Radiation Measurements, Above Two Times Background
Cove Mesa Mines AEC Plot 7 (498)
Sweetwater Chapter, Navajo Nation, Arizona**

A total of 3,925 gamma radiation measurements were collected from the mine site, ranging from 8,056 cpm to 144,844 cpm. Measurements in the vicinity of the waste debris were found at levels of approximately 40,000 cpm. Measurements in the vicinity of the reclamation cap ranged from 80,000 cpm – 140,000 cpm. The measurements are represented in Figures 16 and 17.
